Home Inspection Report

2803 S 49th St, Milwaukee , WI 53219

Sunday September 17, 2017

Precision Plus Home Inspections LLC.
3517 County Line Rd.
Caledonia , WI 53108
262-939-2000
japolzin@gmail.com

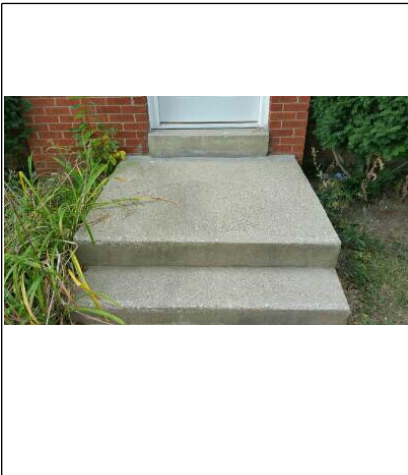
Recommend repair of loose handrail attachment

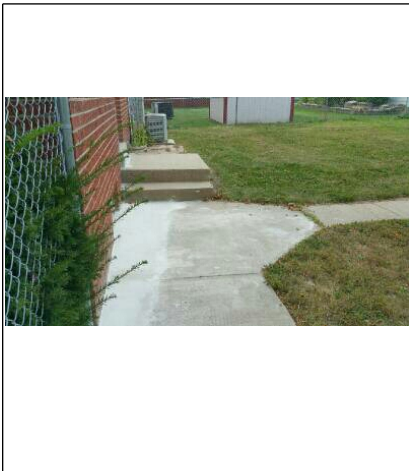
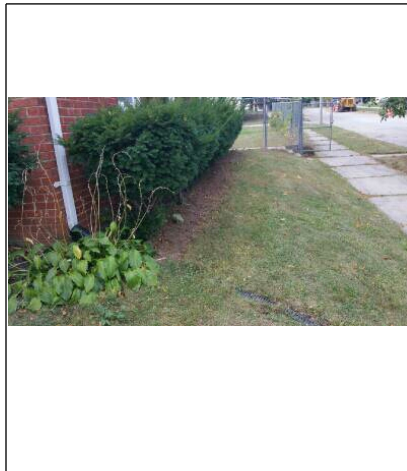
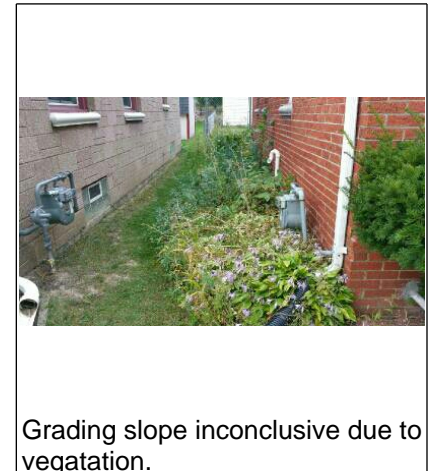
Comments Recommend maintaining a positive drainage slope away from the foundation.

Grading slope inconclusive due to vegetation.

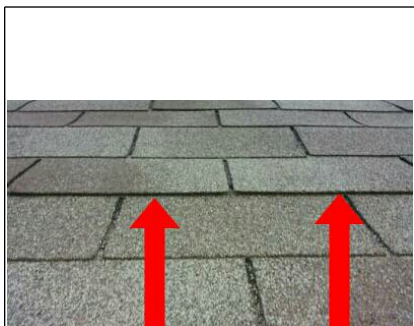
Comments Recommend qualified roofing contractor evaluate roof coverings, shingle tabs do not appear to have adhered properly at tar line.

Loose tab attachment in various areas, recommend qualified contractor evaluate

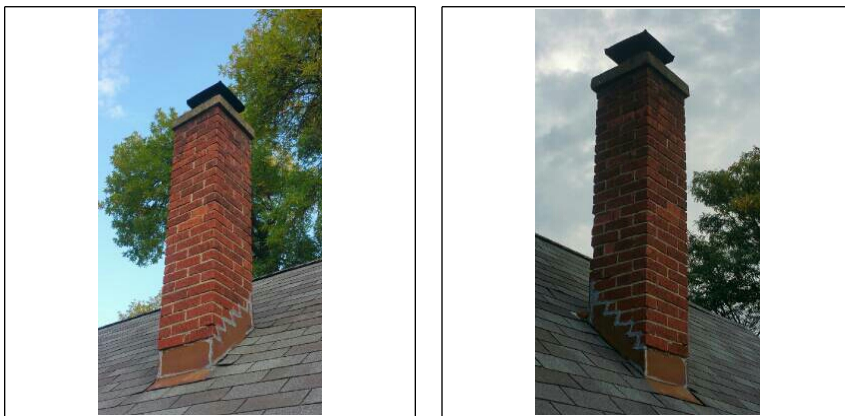
Comments Chimney flue was not accessible so not evaluated
Flaking brick, hot water heater only appliance vented into clay flue, recommend lining.

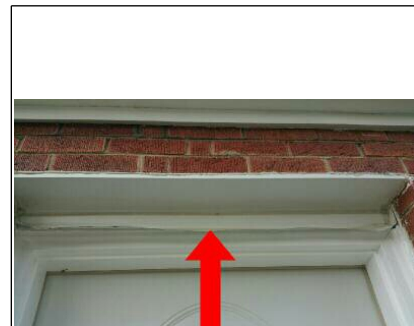
Loose metal recommend repair at front entrance door

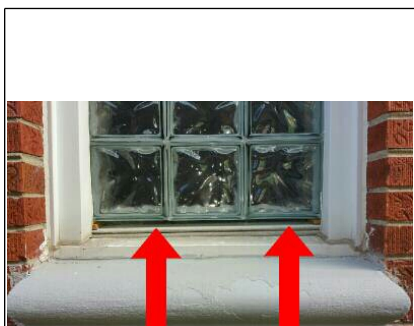
Recommend repair of incomplete exterior trim at south elevation window

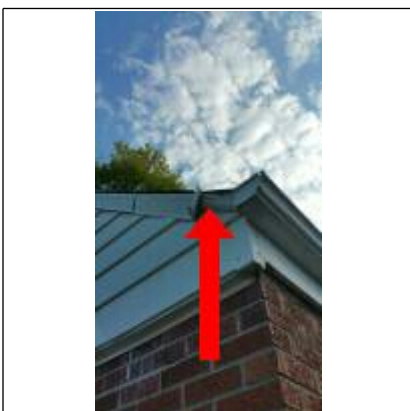
Recommend repair of loose aluminum trim west elevation

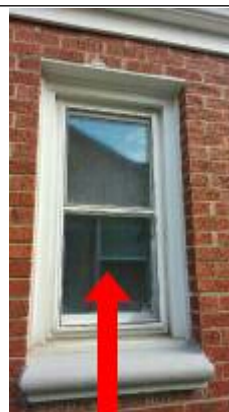
No screen present east elevation

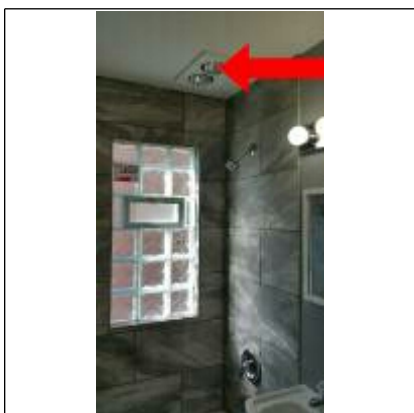
Recommend licensed electrician repair exposed light bulb fixtures, lack of GFCI protection, located in wet location

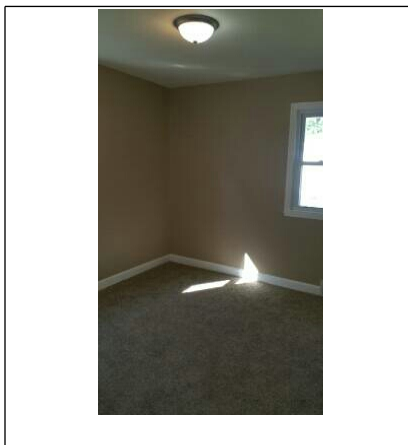
No power present at outlet

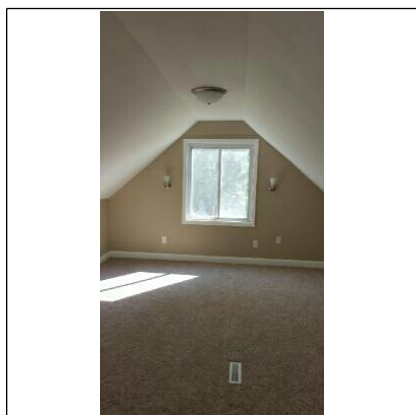
Comments One heat supply, no cold air returns present, heating and cooling performance may be limited.

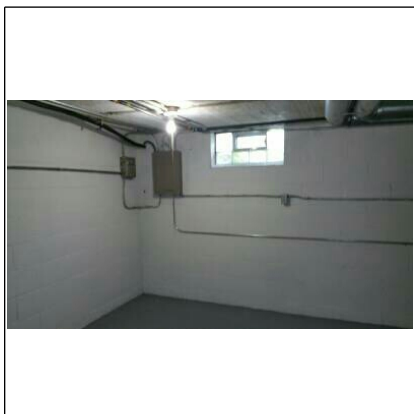
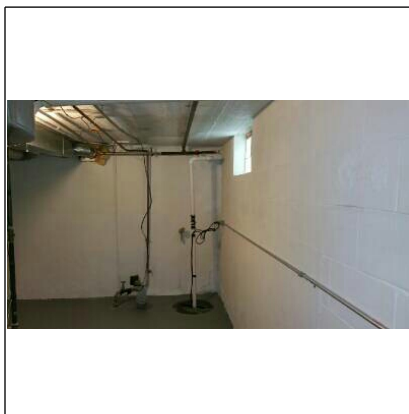
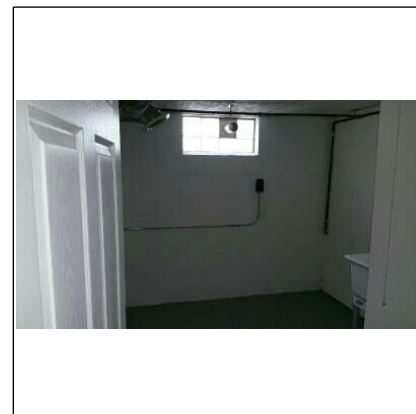
Comments Foundation appeared to be in overall satisfactory condition.
 Some old movement present at west elevation, approximately 1/4-3/8 inch tipping, appears stable at time of inspection Walls have been freshly painted.
 No representation can be made to covered foundation walls.

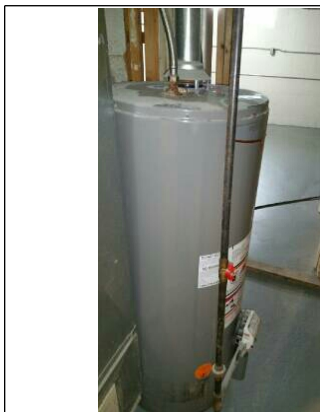
Heavily corroded and not lighting recommend evaluation.

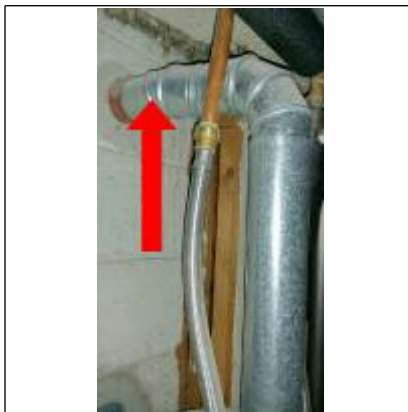
Recommend lining of chimney, hot water heater only appliance vented into clay flue

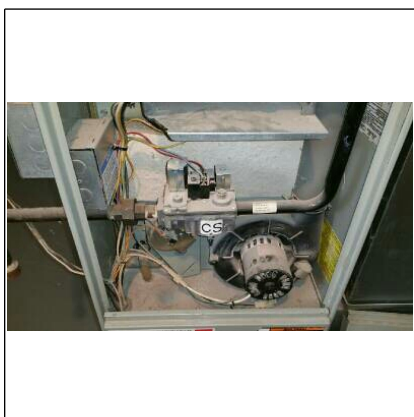
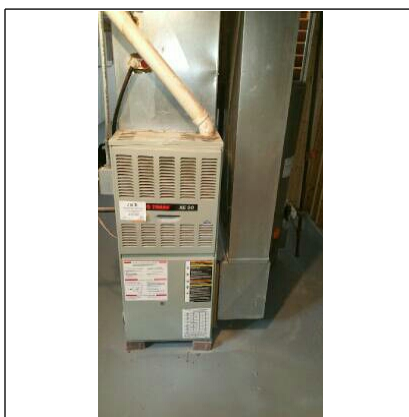
Comments Recommend cleaning and servicing of furnace.

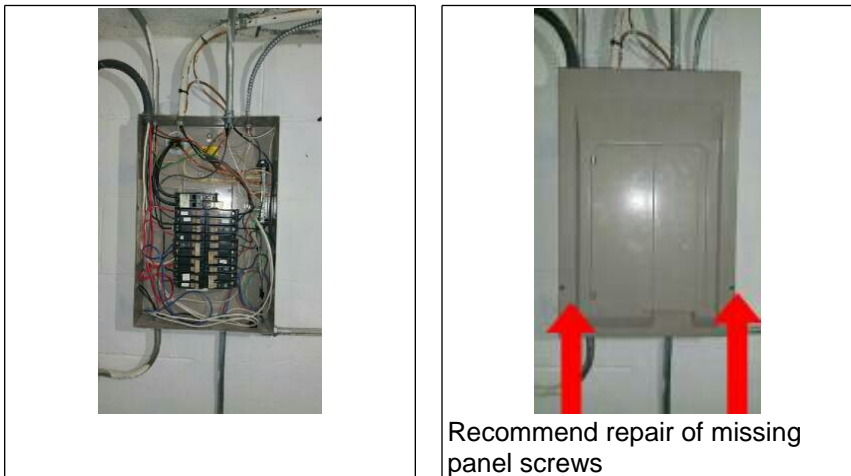
Comments Panel was full and may need to be upgraded for future needs.
 Panel cover was missing some screws recommend adding proper screws to secure panel cover
 Branch breaker distribution appeared normal.
 No signs of overheating were evident at the time of the inspection.
