Home Inspection Report

2803 S 49th St, Milwaukee , WI 53219

Sunday September 17, 2017

Precision Plus Home Inspections LLC.
3517 County Line Rd.
Caledonia , WI 53108
262-939-2000
japolzin@gmail.com

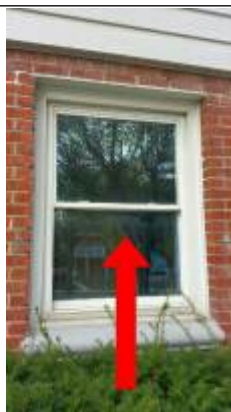
No screen present east elevation

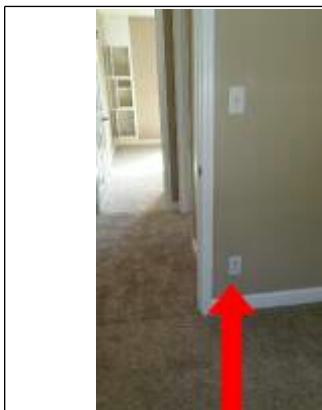
No power present at outlet
