Home Inspection Report

2803 S 49th St, Milwaukee , WI 53219

Sunday September 17, 2017

Precision Plus Home Inspections LLC.
3517 County Line Rd.
Caledonia , WI 53108
262-939-2000
japolzin@gmail.com

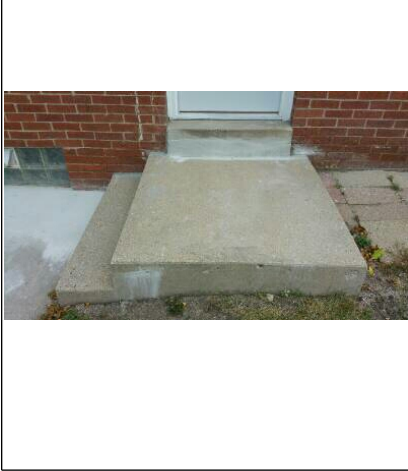
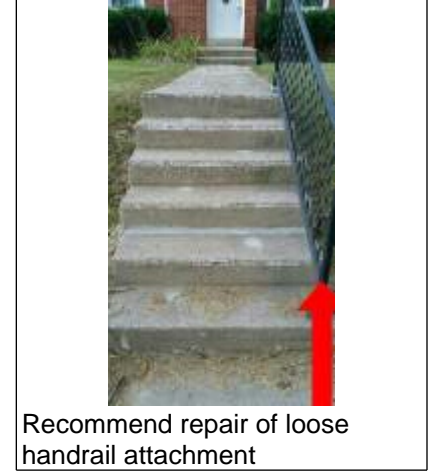
Recommend repair of loose handrail attachment

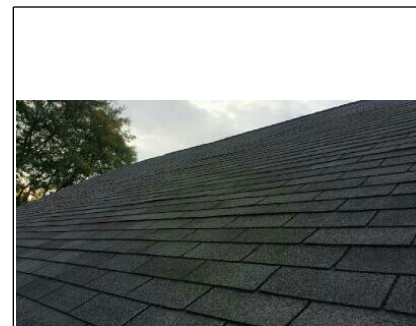
Comments Recommend qualified roofing contractor evaluate roof coverings, shingle tabs do not appear to have adhered properly at tar line.

Loose tab attachment in various areas, recommend qualified contractor evaluate

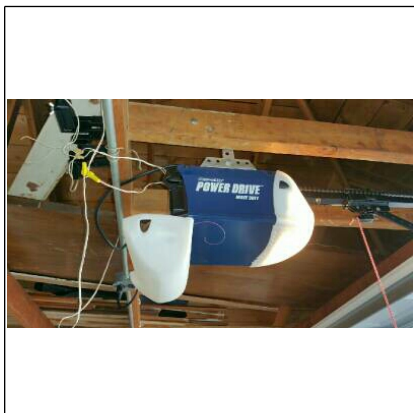
Electric eyes too high above ground, potential safety hazard. Recommend 6" from floor
 Electric eyes mounted on ceiling, improper installation and a safety hazard. Recommend repair

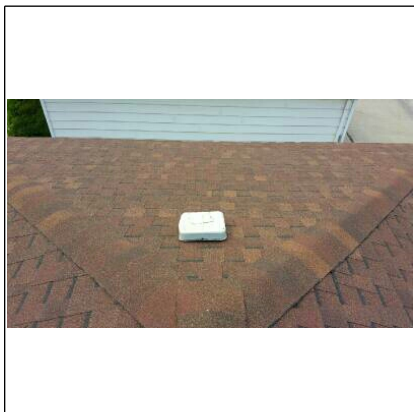
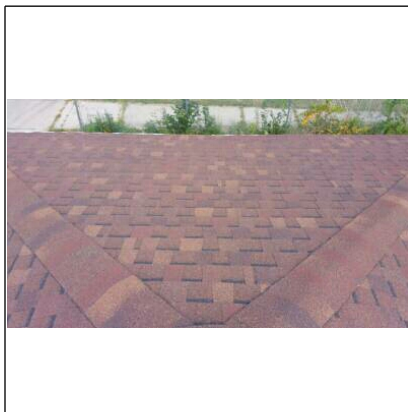
Roof appeared to be overall intact and in satisfactory condition.

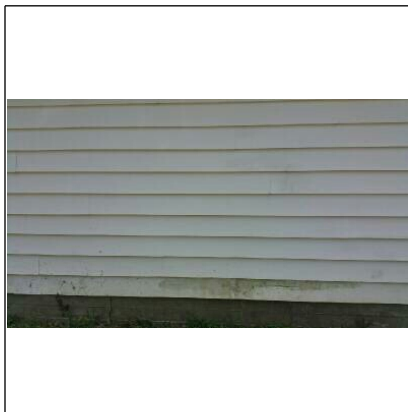
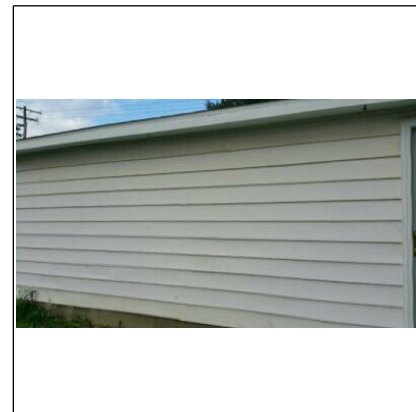
Wear and tear present in functional condition.

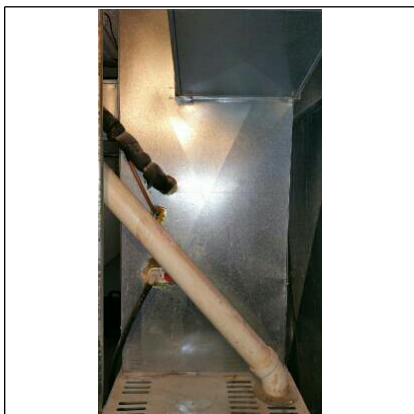
Comments A/C is operating outside the proper temperature differential, have HVAC contractor examine.
